## Images of *Bubas bison* tunneling & dung burial on a clay soil profile

'Native' soil at Merton: thin organic layer (~2-5cm) with minimal root development, over compacted clay-loam (~5-15cm), over buckshot (~15-25cm), over clay subsoil (25+cm).

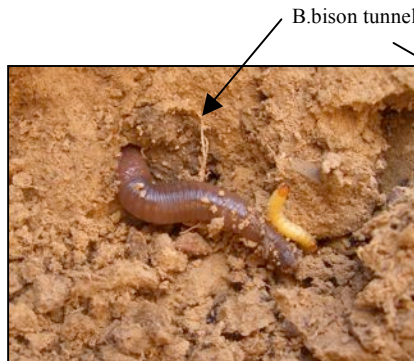
Earthworm moving along an old dung-filled tunnel (at 30 cm depth). Note plant roots & beetle larva, also found at this depth.

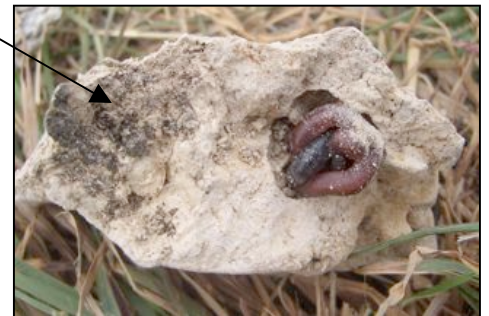
Earthworm aestivating in a soil cavity directly adjacent to *B. bison* tunnel (at 12 cm depth).
